# **Preserving the Textile Block at Florida Southern College**

A REPORT PREPARED FOR THE  
WORLD MONUMENTS FUND  
JEFFREY M. CHUSID,  
PRESERVATION ARCHITECT  
18 SEPTEMBER 2009

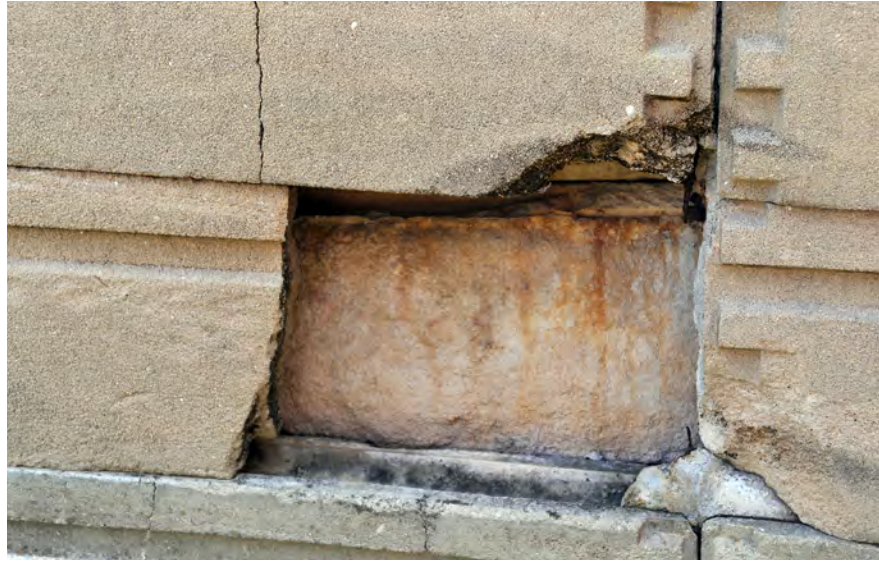
This image captures many of the conservation issues found in the textile block at Florida Southern College. The reinforcing steel has rusted and broken away part of the face of a block. Continuing rust jacking has also cracked the blocks above and below the partial block. Repairs have been attempted with non-compatible materials without stopping the progression of the damage. Meanwhile, the wall itself seems to be suffering a structural failure, collapsing the two wythes together.

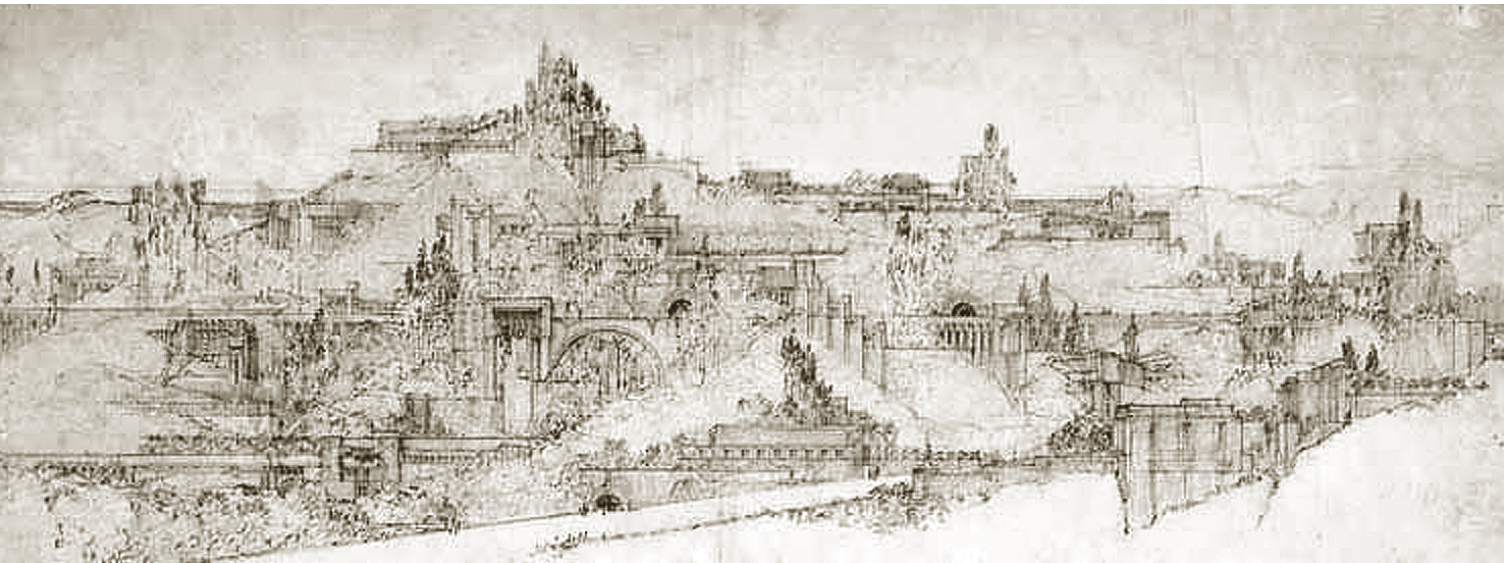
Above: a sketch of the speculative Doheny Ranch project, Wright's theoretical essay on block architecture in the Hollywood Hills. Below: a stone panel from Uxmal, Mexico, a primitive 'mono-material' precedent.

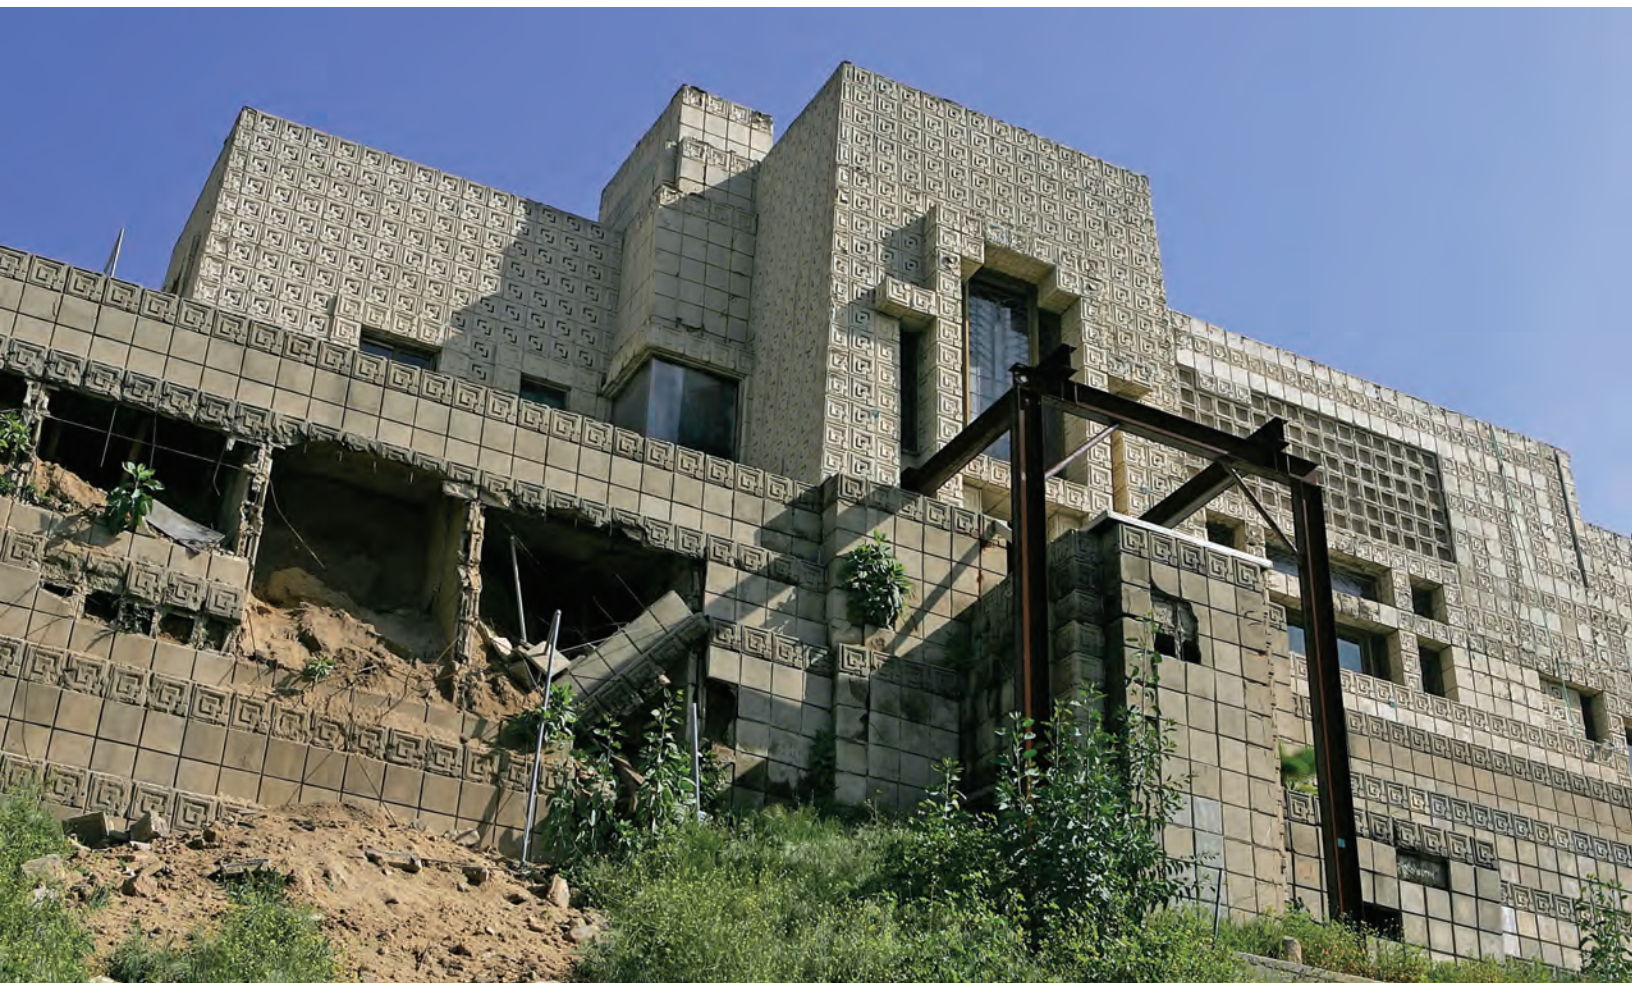
The 1994 Northridge earthquake severely compromised the south façade of the Ennis House

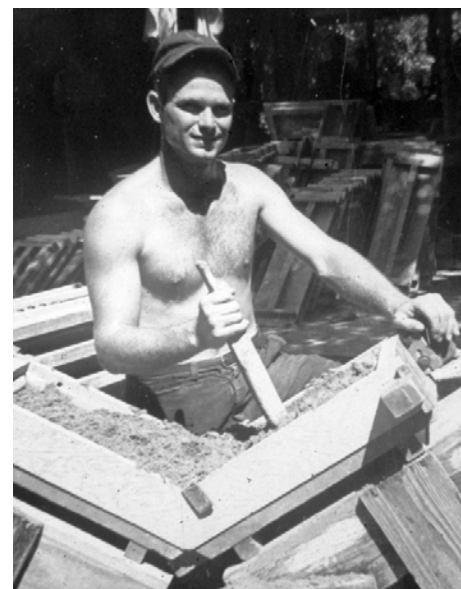
Wright's plans for the textile-block buildings had to address close to 40 different block types. Here are the drawings for the obtuse corner blocks being made by a student in the image below.

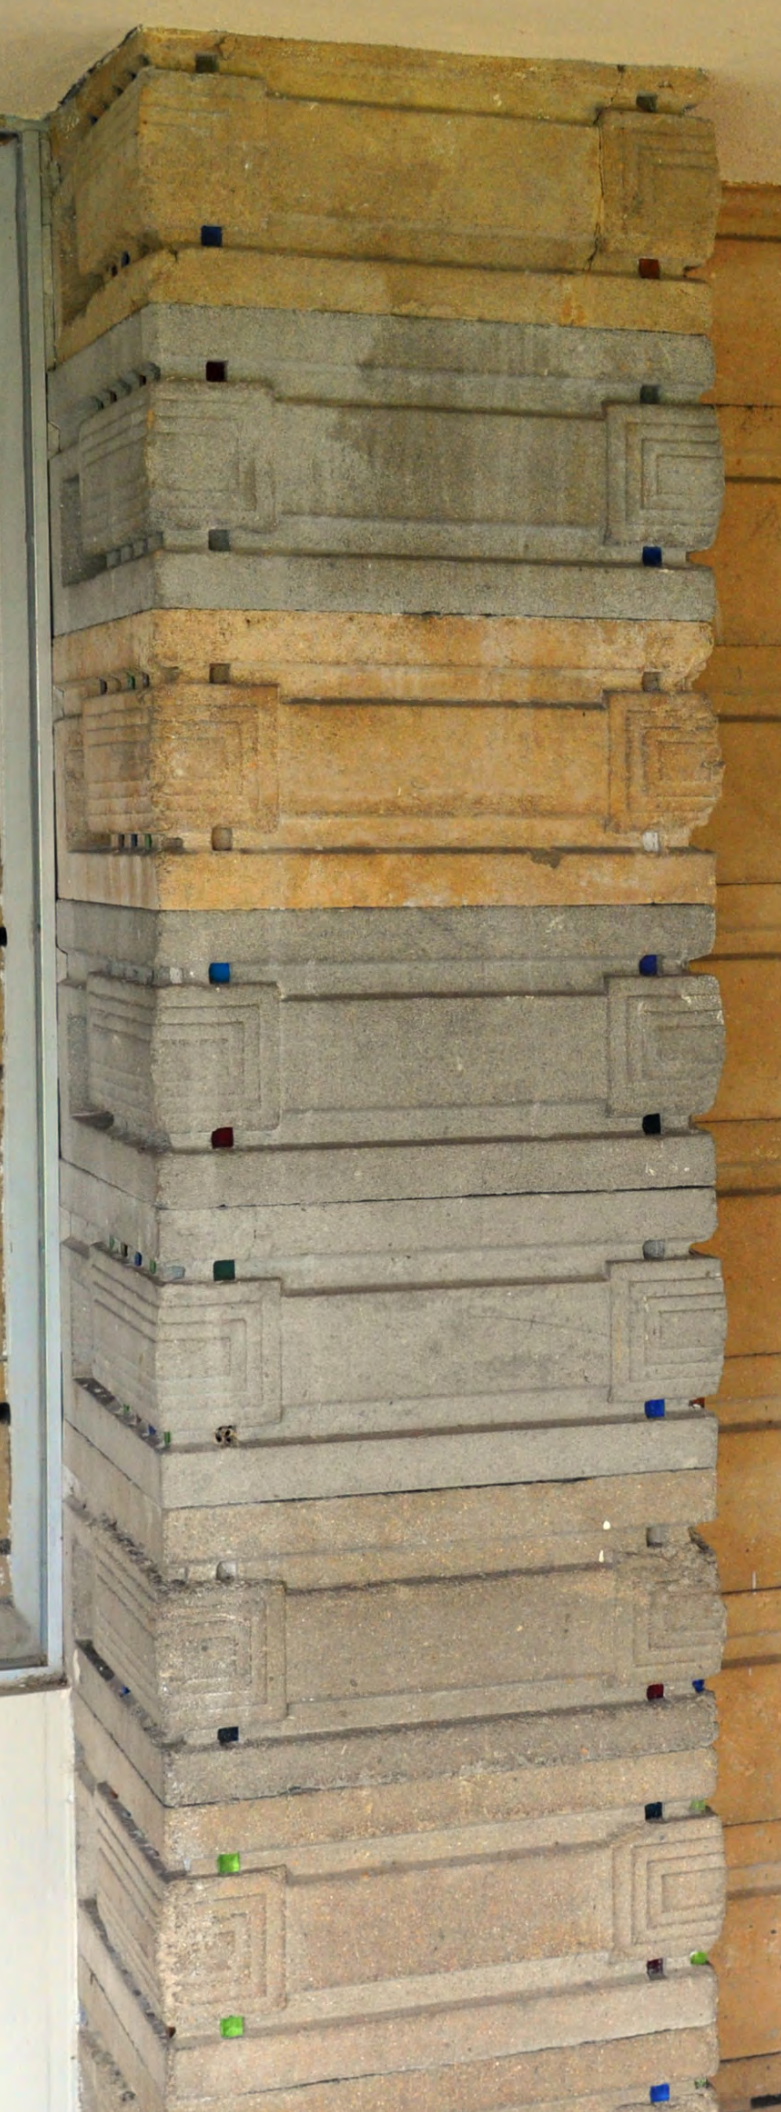
The administration building has block demonstrating a wide range of colors, likely because it was built of samples left over from block-making experiments during the early years of the project.

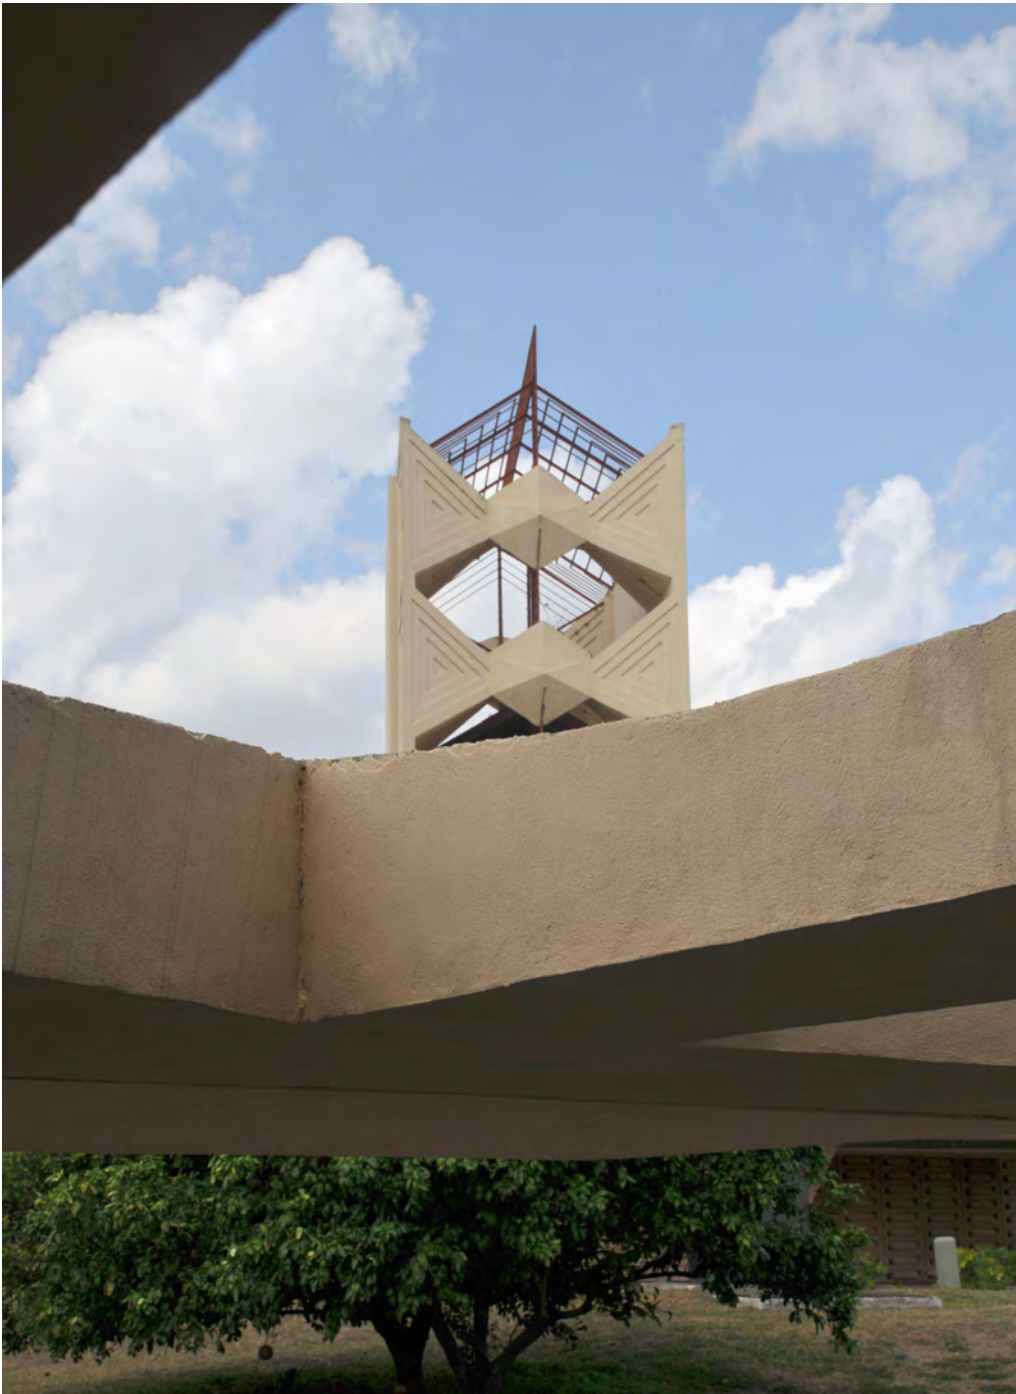
The blocks in the round theater were painted by students, and are now being cleaned as part of a restoration of the structure under the direction of Mesick Cohen Wilson and Baker. .

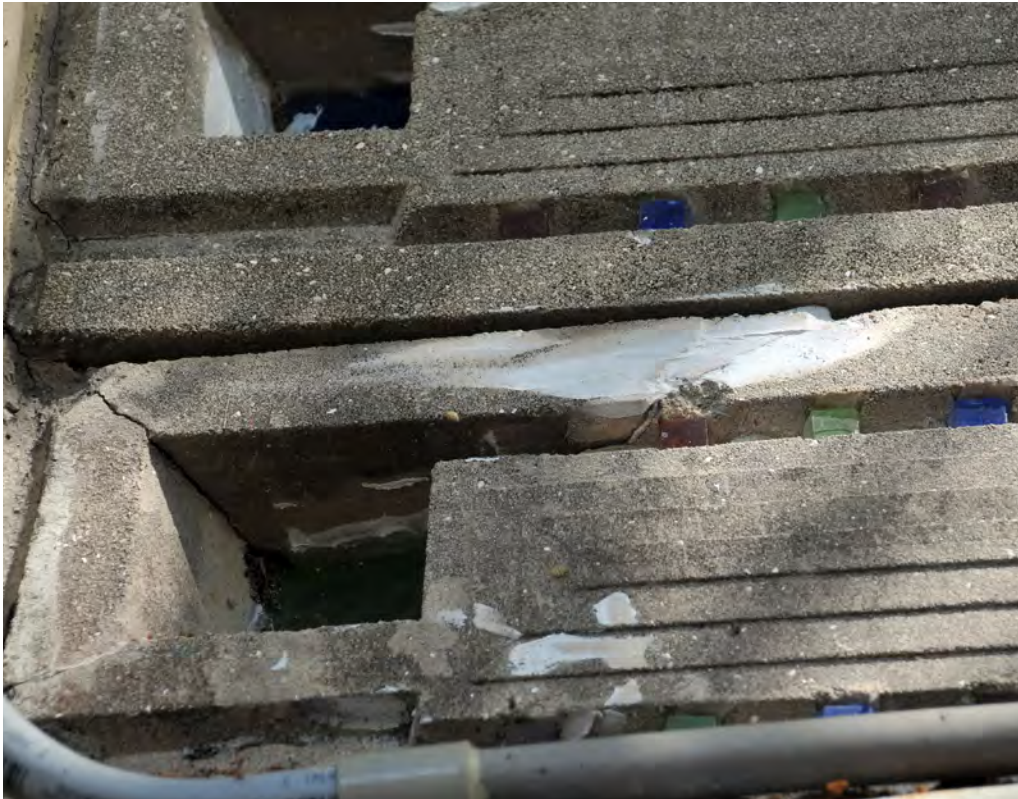
The lower block is not in line with the upper block, suggesting problems with the vertical channel. Cracks at the corner and joint are related. The addition of electrical conduit to the facade is unattractive, as is the non-matching caulk. The blocks are also quite dirty, probably from biological staining.

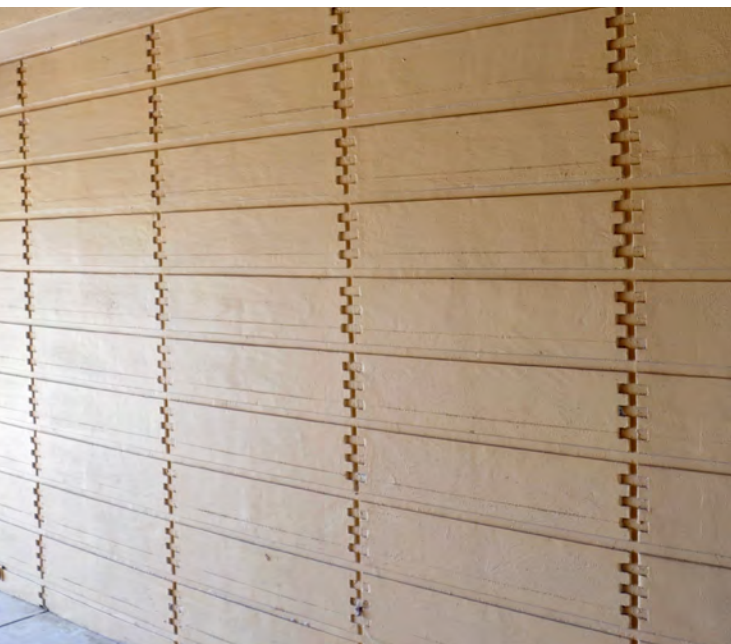
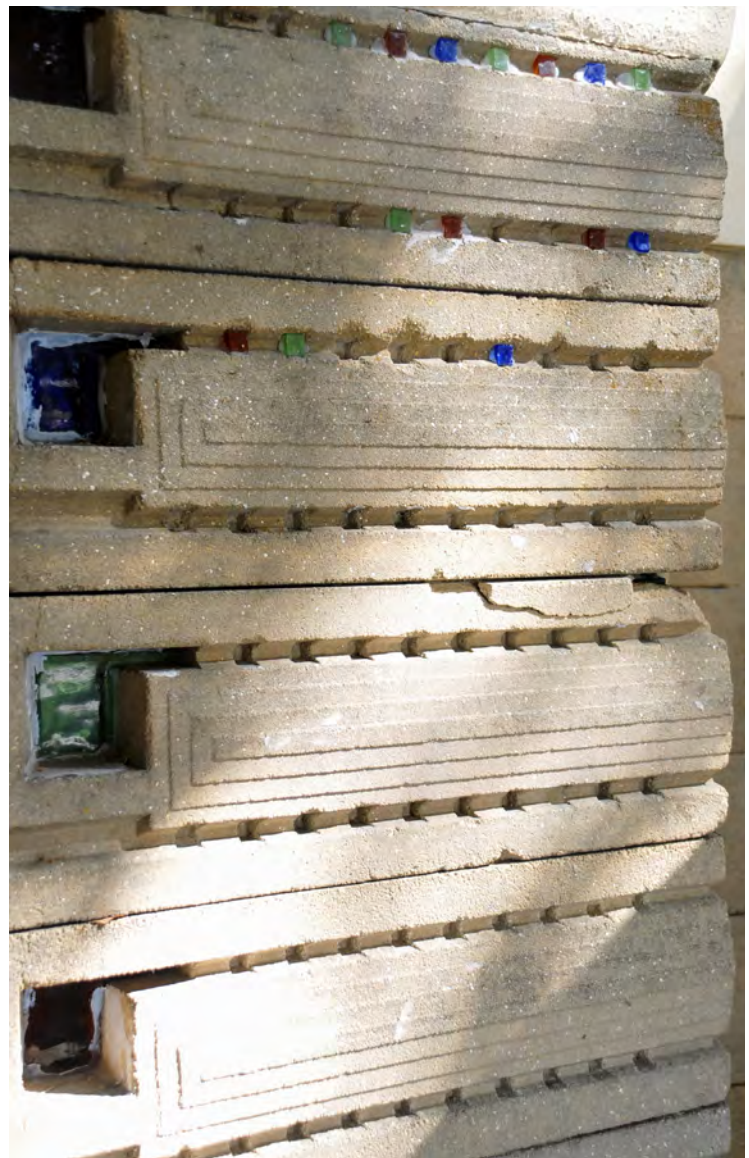
THE LOWER BLOCKS ARE CRUSHED IN THIS WALL, POSSIBLY BECAUSE OF A LATER ADDITION OF CONCRETE TO THE WALKING SURFACE. SURFACE WATER WILL ALSO MAKE THE LOWEST ROW OF BLOCKS WEAKER.

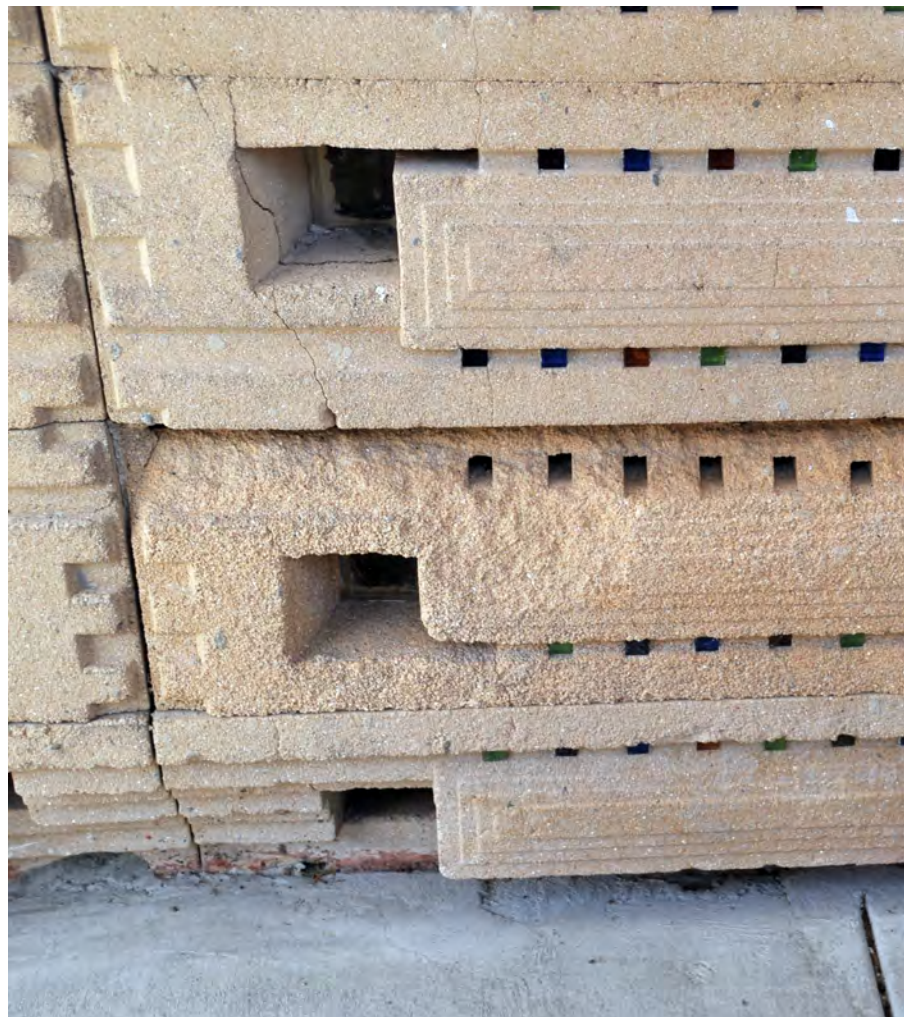
The second block in this column is significantly more eroded than those around it. The color difference is probably the result of washing away the surface dirt and exposing the pigmented mix, but it may also indicate a slightly different, and weaker, mix. The upper block is experiencing incipient failure at the large glass insert likely due to expansion of the steel in the joint.

The poured-in-place coffer that accommodate the windows are stiffer than the blocks, but the connection between them and the textile-block system is unknown. Failure of the vertical joint could be the result of expansion of the steel in the joint, or a consequence of the connection between the two systems.

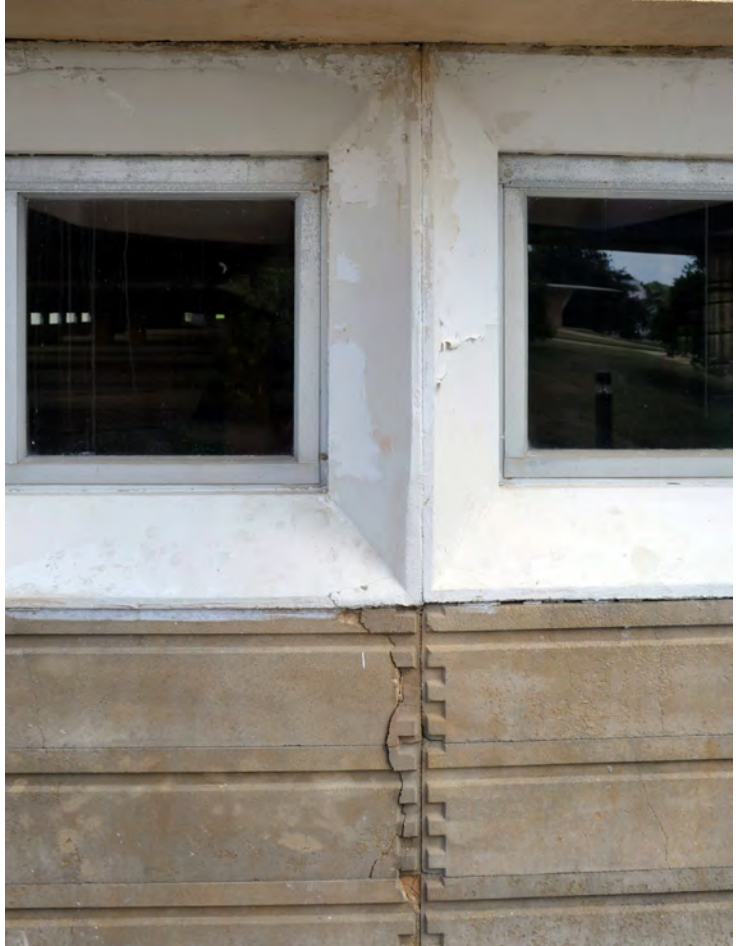
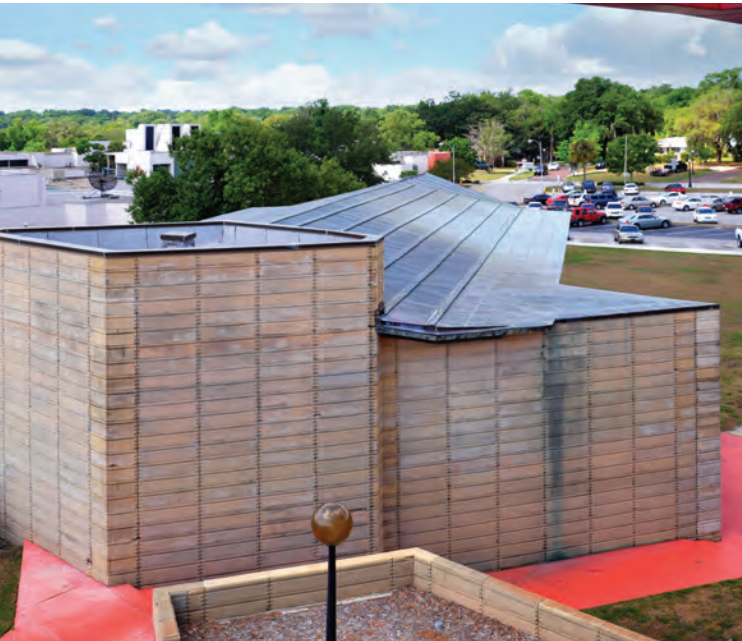
the block on Danforth Chapel shows efflorescence at the top, probably the result of water infiltration from the parapet, as well as staining from water overflowing the flat portion of the lower roof. More efflorescence is visible at the acute corner.

the matrix of grout tubes are harder than the surrounding blocks, and can break them. They are also the component of the system that best resists lateral forces. The outer wythe of the block at the left of the tube is gone, the inner wythe is pushed out by the dirt behind it.

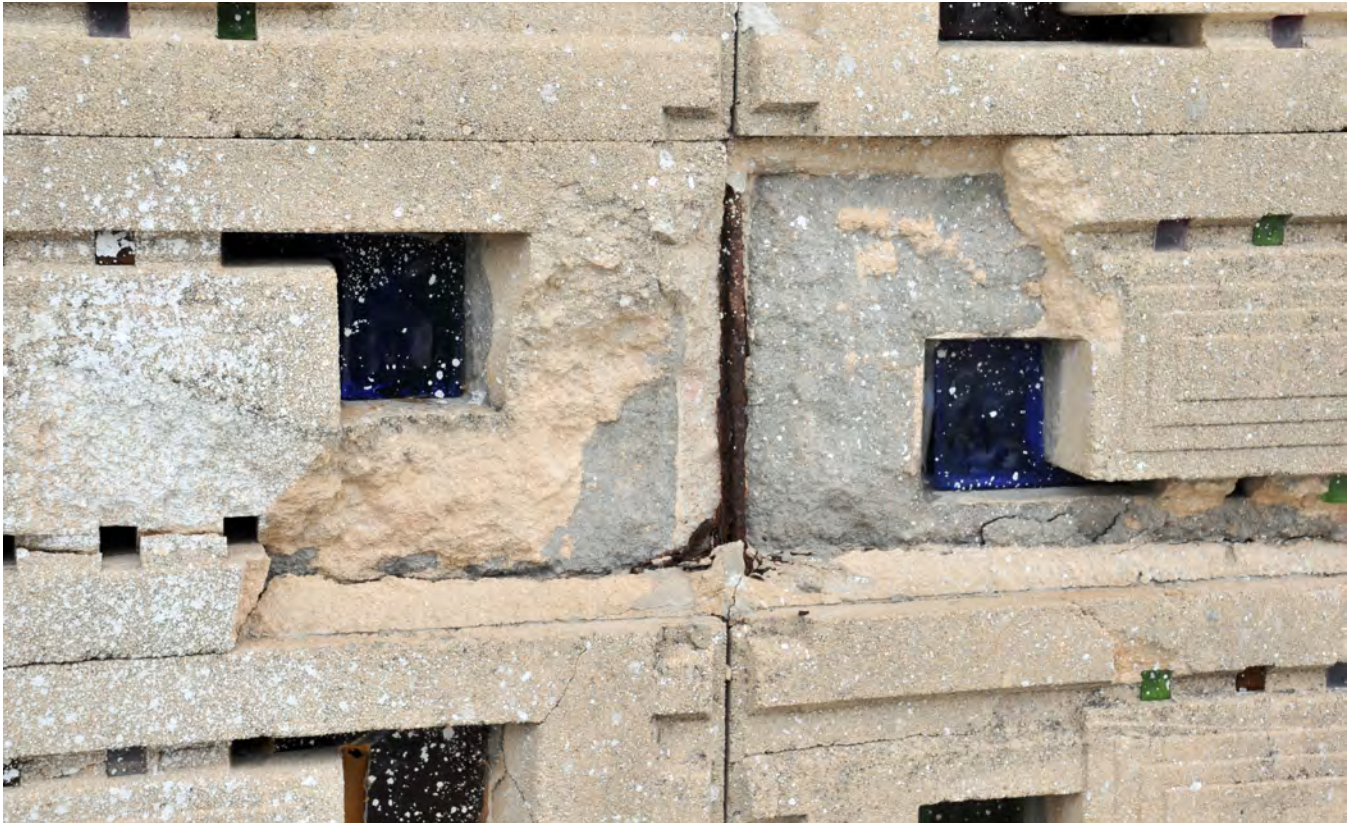
The difference between the two mixes found in most blocks is visible here, where the joint seems to have provided a fracture plane for the block to split when pressured by the rusting reinforcement. The spray of paint is evidently an unrelated accident.

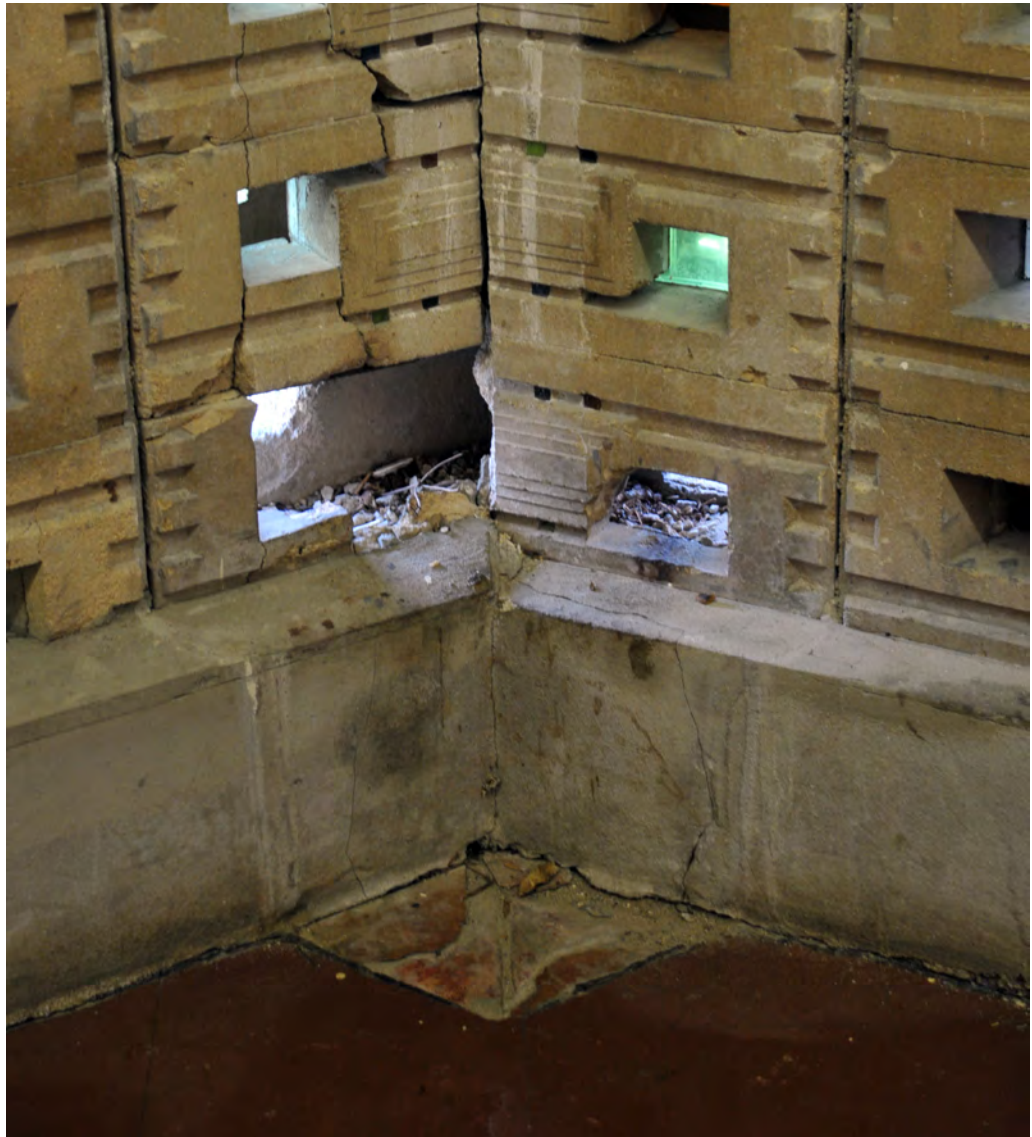
Removal of a vertical duct or other element added previously in this corner exposes damage caused by its trapping moisture next to the block. The block is also vulnerable to expansion and crushing. The lowest block at the left was a ventilator block, meant to accommodate an operable panel.

The block joint here is not in the reveal, but above, in the flush seam. That makes failure in the horizontal joint even more visible and problematic than elsewhere on the campus. The failure in the joint below the coffered area may be indicative of a problem (as in the previous image). Biological staining can also be seen the lower portion of the wall, which would be the most damp.

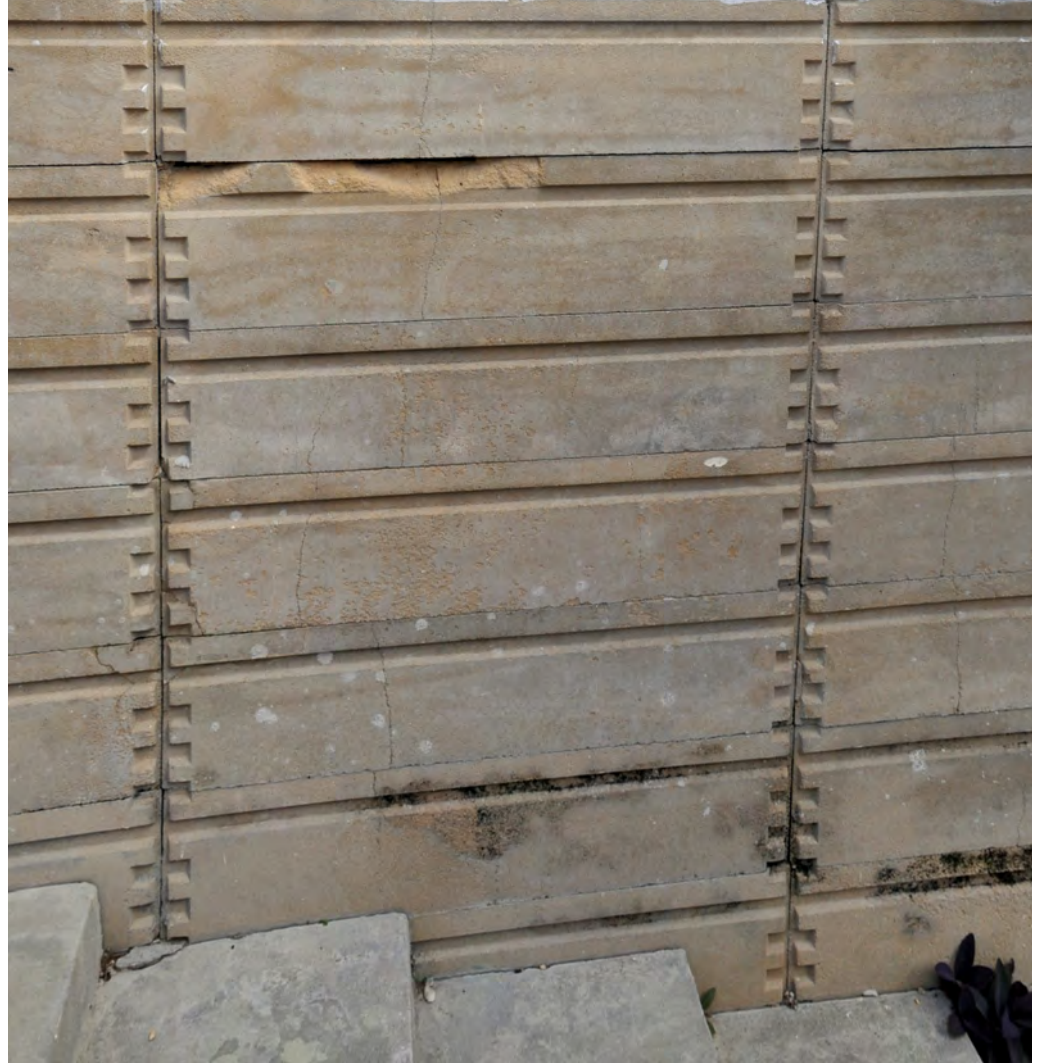
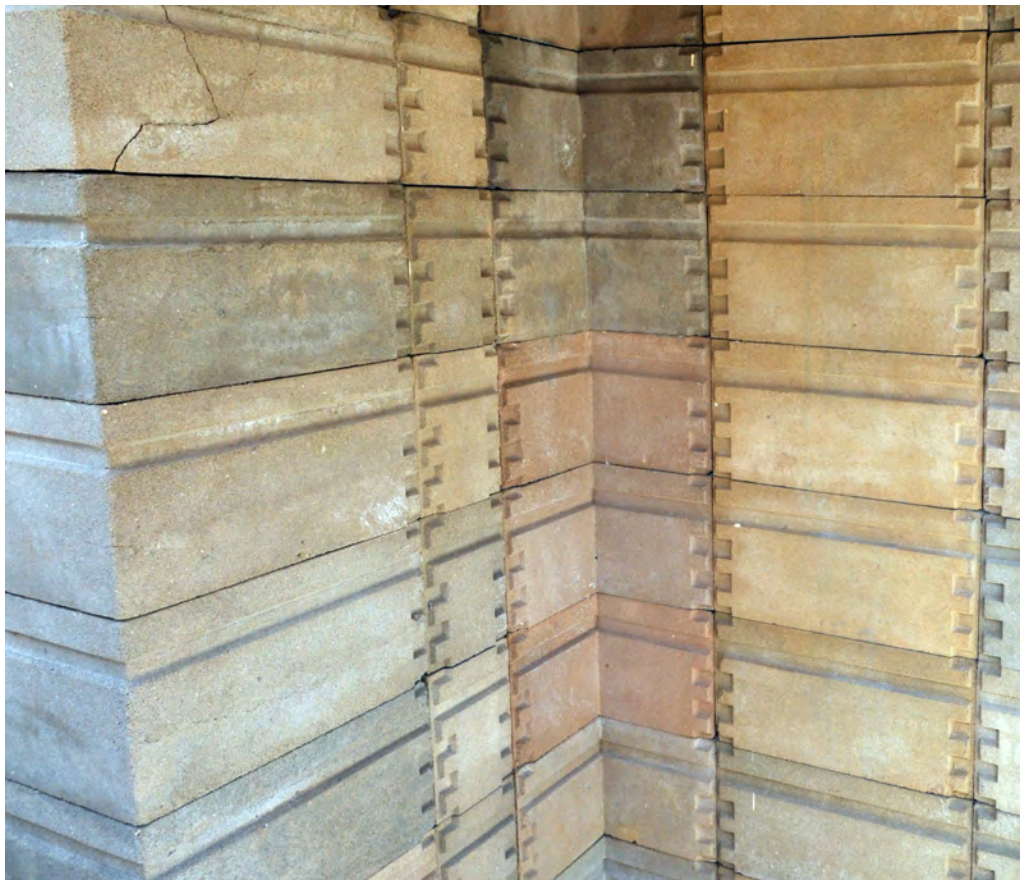
The presence of extensive efflorescence in this area suggests that the reinforcing is subjected to excessive moisture. The block at the left is also the most exposed to the elements. Both of these factors, along with the issues of stiff corners and imperfectly bent reinforcement need to be explored to understand the source of the crack seen here.

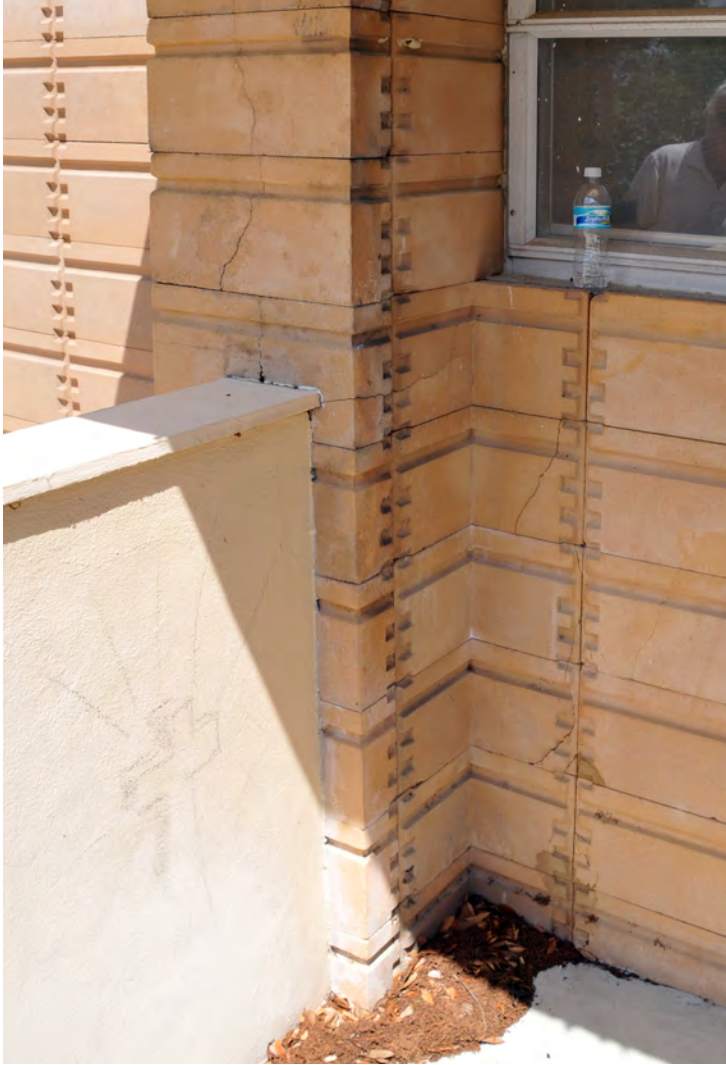
The textile block system seems to be particularly vulnerable to penetrations, such as that caused by the solid railing seen here. (See a similar situation from the Freeman House on page 11.) This is likely due to differential movement, but also to standing water on the coping.

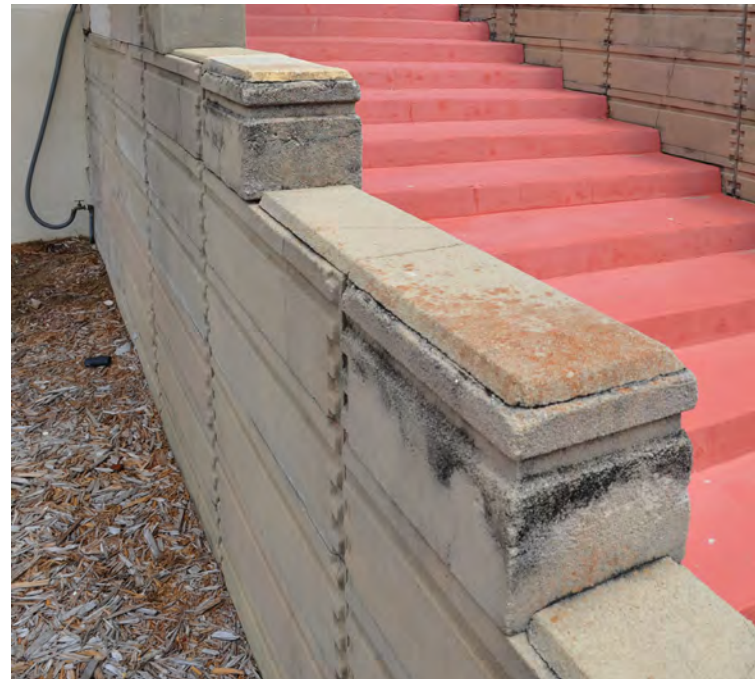
Stairs and retaining walls are capped with long, thin cement coping that is relatively brittle, and does little to prevent water infiltration into the wall. Erosion and biological staining are visible here.

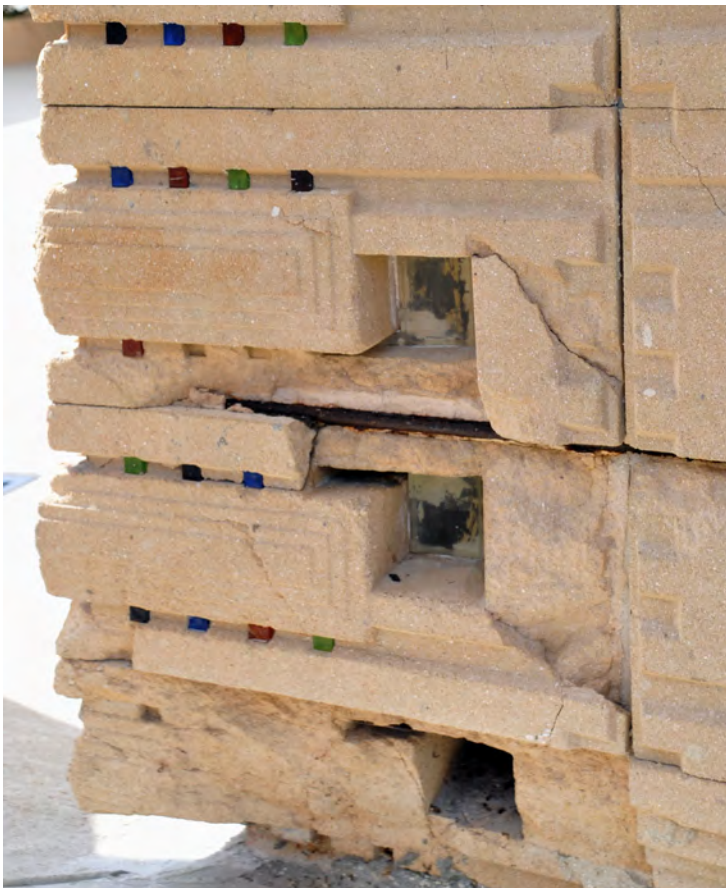
Rusting reinforcement has broken both the grout tube (the lighter concrete) and the block. Blocks in contact with surface water will wick moisture into the reinforcing. Blocks lower on a wall will experience more surface run-off as well. In addition, corner blocks are vulnerable to cracking from thermal expansion of the wall plane.

Coping stones may not be adhered to the wall below. Here one can see the typical failures of the system: grout that only partly fills the horizontal channel, and reinforcing that rusts away as a result. In the case of the coping stones, the rusting steel will lift them, widening the joint and hastening the deterioration. The blocks on both wythes are also experiencing vertical cracks that may be a result of the lateral pressure of the steps and fill.

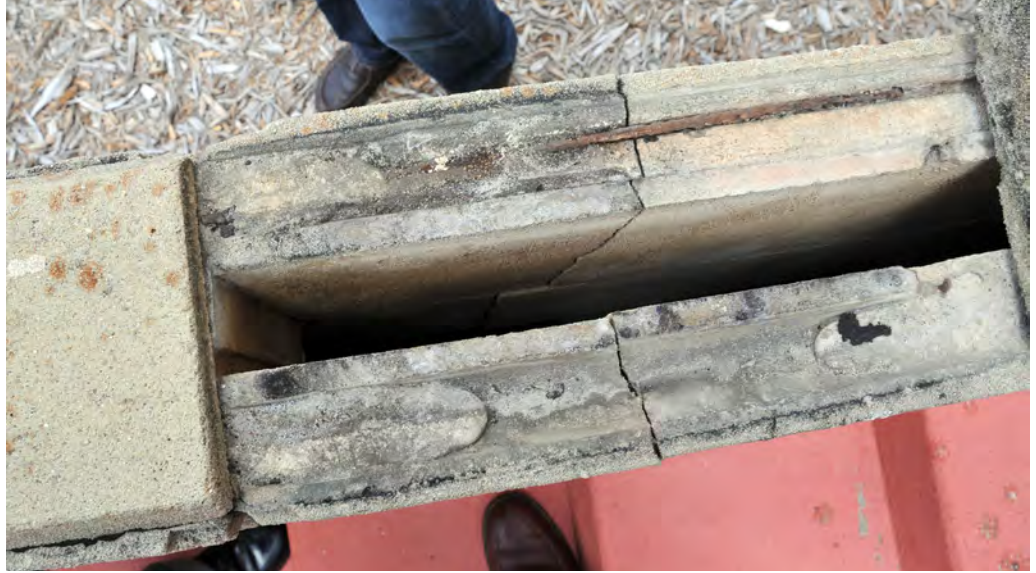
Thin and brittle coping stones fracture easily. Their absence reveals missing grout and steel.

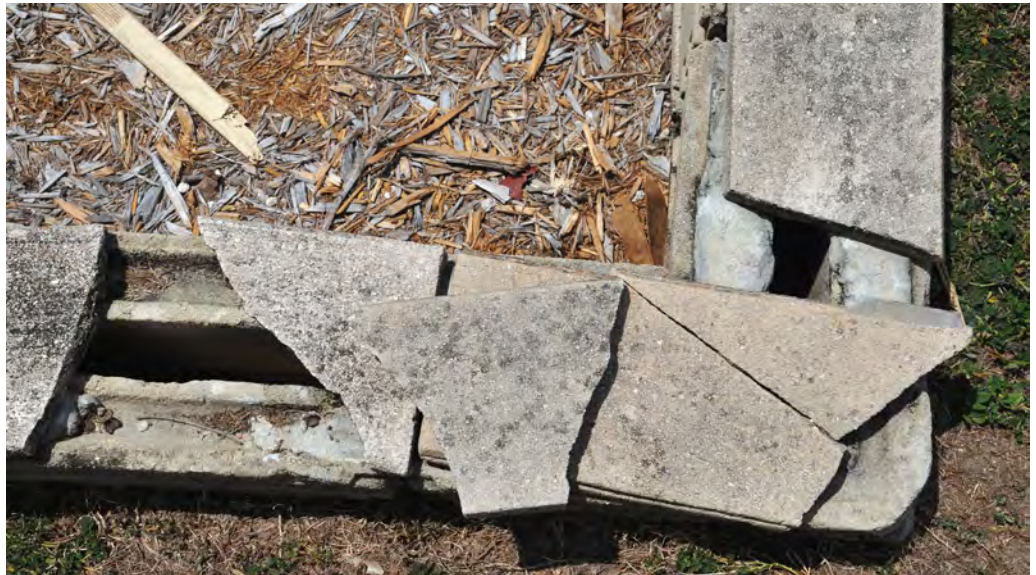
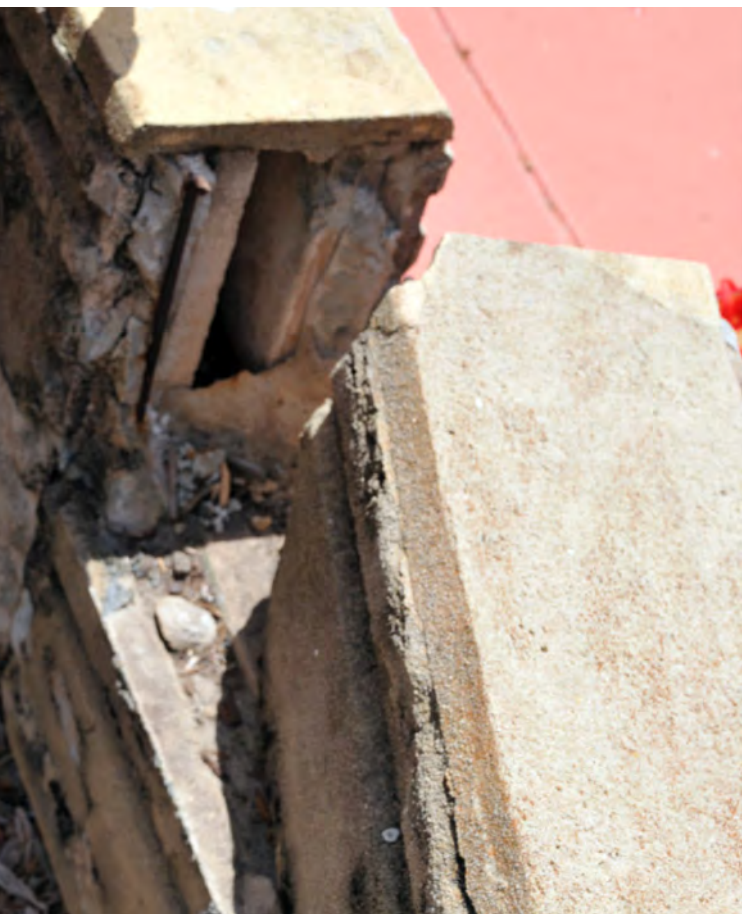
Conditions seen above are visible here in the next joint down from the top, essentially freeing both both coping and blocks from the wall. Note that the grout from the vertical joint apparently flowed across the gap between the wythes. Attempts were made in the past to repair this, as can be seen from the patches on the coping stones, but without addressing the underlying failure of the reinforcing.

There appears to be at least three different mixes or generations of block in this image, as well as attempts to patch both a yellow and pinker block. The wall needs to be disassembled and re-constructed.

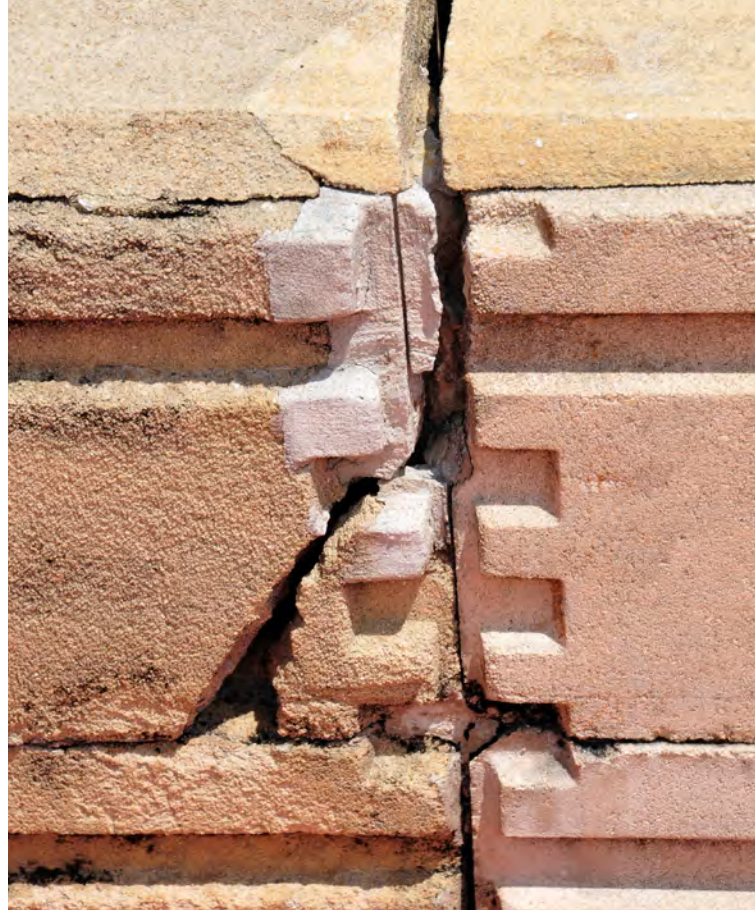
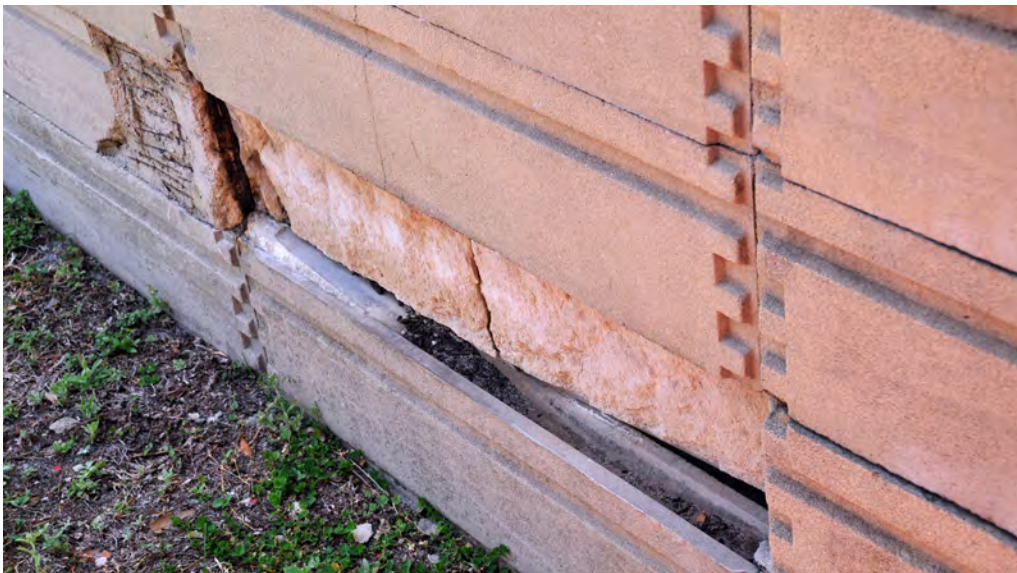
Water moving through the retaining walls causes extensive damage, as does horizontal pressures that buckle the block (note the vertical crack continues up the face of the other blocks). Here, block has split in two across its length, as well as vertically. The face is gone, leaving the back half in place. The grout is only partial in the channel, the steel is rusted out, and the damage continued to the block at the left, which has been partially patched.

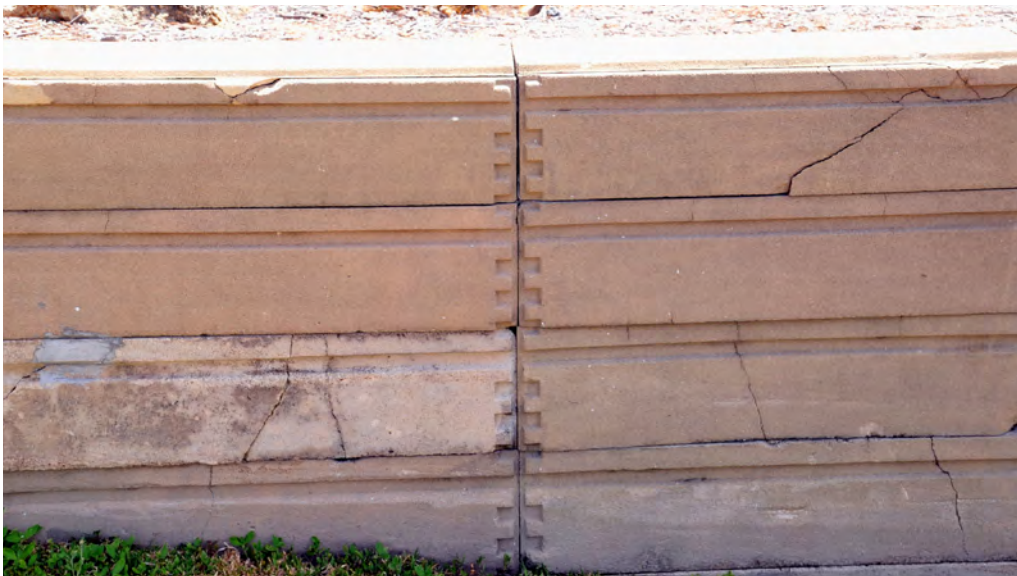
This area of retaining wall exhibits the same failure as seen in the last photo, but not as advanced. Again, an attempt was made to patch a missing piece, with a non-color matched patch. Portland cement repairs will be destructive to the block, which is softer.
